**SOLID FILM LUBRICANTS AND THERMAL CONTROL COATINGS FLOWN ABOARD THE
EOIM-3 MDA SUB-EXPERIMENT**

Taylor J. Murphy*, Kaia E. David*, and Hank W. Babel**
McDonnell Douglas Aerospace
Huntington Beach, CA 92647
Phone: (714) 896-3311/Fax: (714) 896-5034

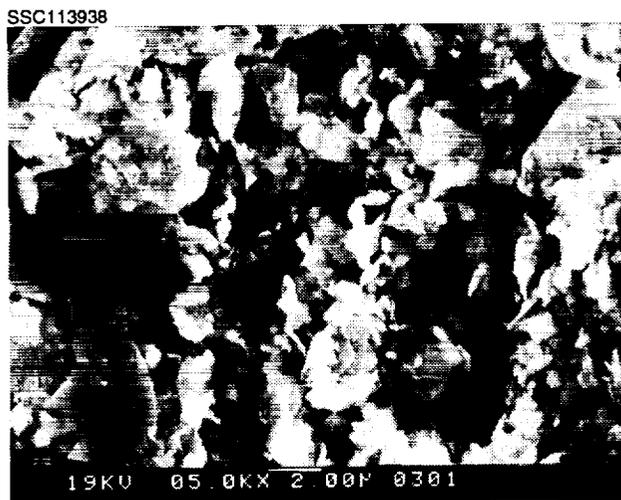
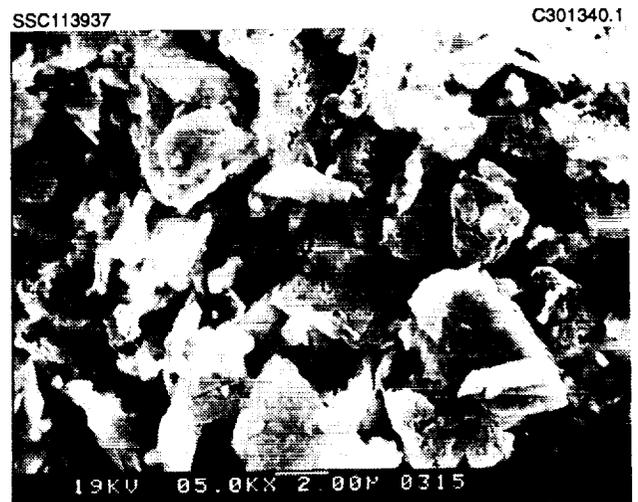
Figure 1. SEM photographs of lubricant 1 passive tray sample.

Comparison of the SEM photographs of the exposed and unexposed surfaces of the passive tray sample (Figure 1) shows a “worm-eaten” preferential erosion of particular materials that is typical of the exposed material on all three tray samples. EDX analysis revealed no gross difference between materials in the eroded and non-eroded areas. EDX indicated that the eroded material was MoS₂, but because the EDX was conducted at a high power, the analysis may have detected the material lying underneath the eroded material. Erosion appears to be slightly more extensive in the passive tray sample than in the heated tray samples (Figure 1b and Figure 2).

There is a transition zone between the unexposed and the exposed areas on the two heated samples, which is evidenced by a light region on the SEM photographs. EDX analysis of these areas indicates a higher level of aluminum than in other areas, suggesting the lubricant had been rubbed off either by the sample carrier or by other means. Otherwise, there is little discernible difference between the three specimens.

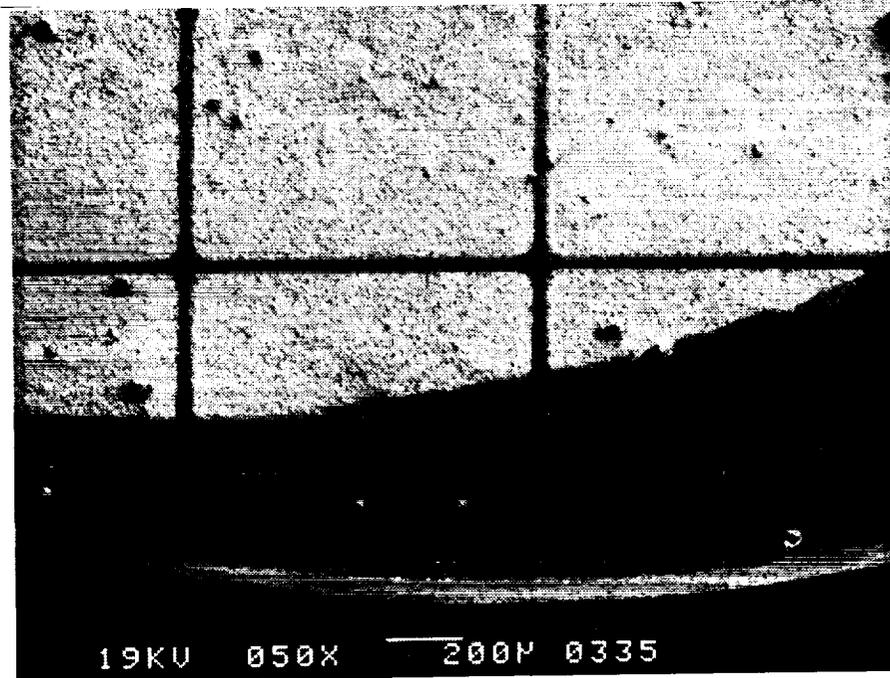
Figure 3. SEM photograph of unexposed, exposed surface of lubricant 2.

The only specimen of this lubricant was on the 120°C tray. The specimen had a screen installed over it. In the SEM photo (Figure 3), the exposed areas are distinctly lighter in shade than the unexposed areas. SEM photos also show a semitransparent material, presumably the polyimide binder, on the unexposed surfaces (Figure 4). The exposed samples appear to be missing this material. EDX analysis indicates no discernible difference in materials present in the unexposed and exposed areas.

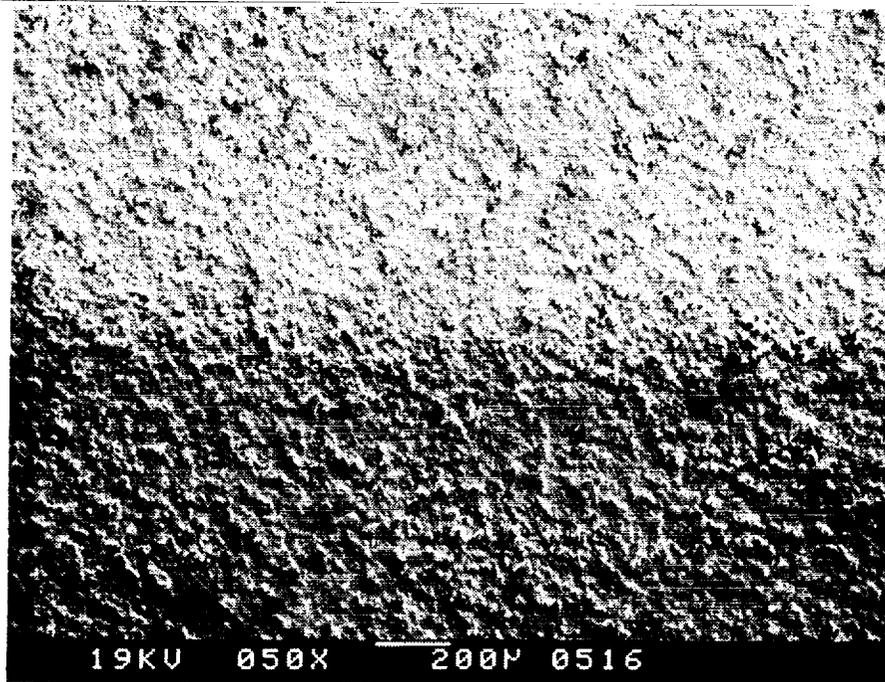
Figure 5. SEM photograph of transition from unexposed to exposed area on lubricant 3 60°C sample.

There is no discernible difference between the three tray samples in the SEM photographs. On all the samples, the exposed area is lighter than the unexposed area on all samples (Figure 5). There is a semi-transparent material, assumed to be the phenolic binder, on the unexposed surfaces. The exposed surfaces lack this material (Figure 6). EDX analysis shows very little difference between the materials in the exposed and unexposed areas, and very little difference between the samples themselves.

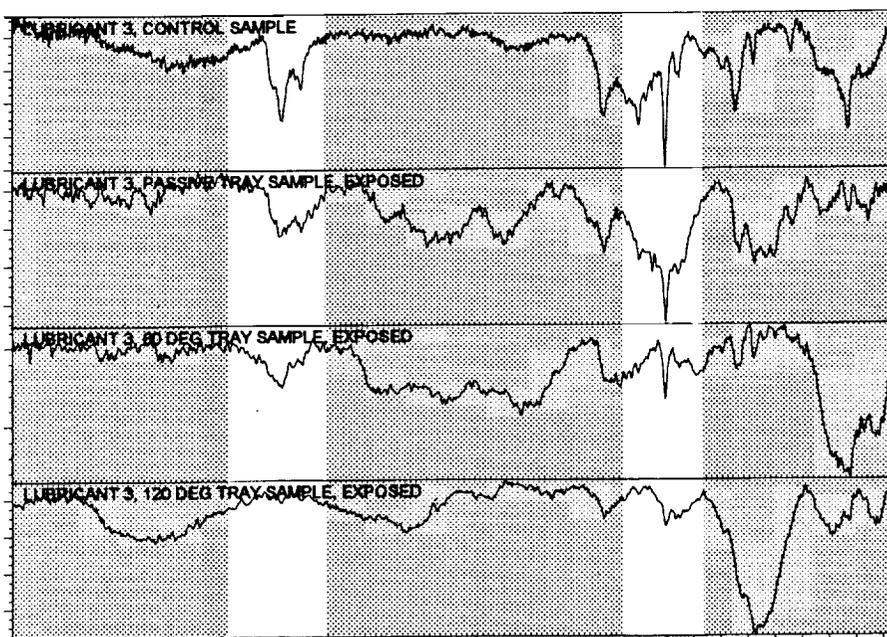
Figure 7. FTIR plots of lubricant 3 samples with phenolic peaks highlighted.

FTIR analysis of the surfaces of each specimen indicates no distinguishable binder on the exposed surface of the 120°C specimen, slight indication of binder on the exposed surface of the 60°C specimen, and a stronger indication on the exposed surface of the passive sample (Figure 7).

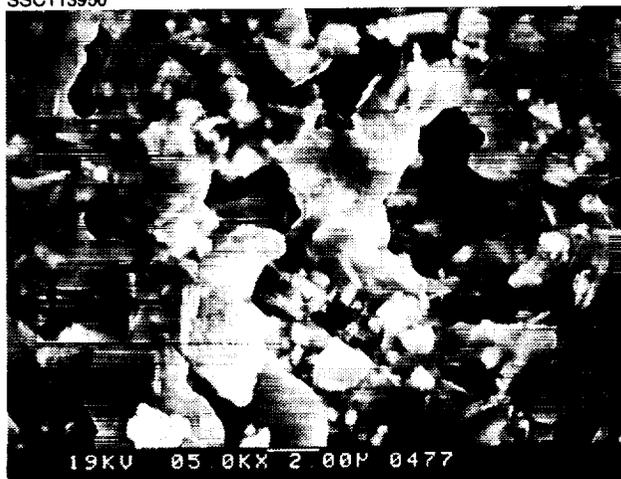
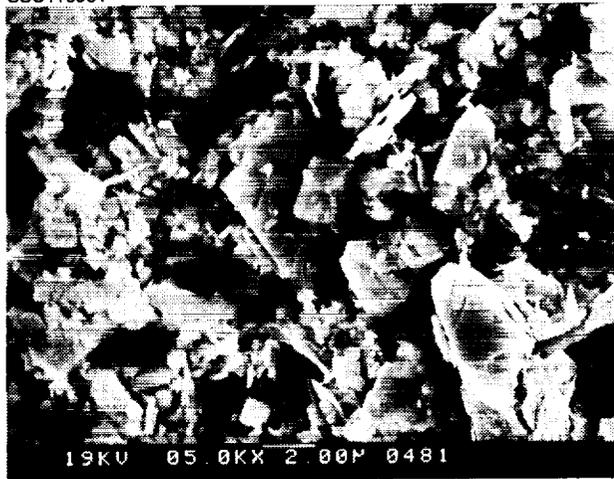
Figure 8. SEM photographs of unexposed, exposed surfaces of lubricant 4 60°C tray sample.

There is no discernible difference between the three specimens in the SEM photographs. The exposed area is lighter than the unexposed area on all samples. There is a semitransparent material, assumed to be the phenolic binder, on the unexposed surfaces (Figure 8a). The exposed areas appear to have some binder left (Figure 8b). The binder that is left does not exhibit the preferential erosion observed on the Lubricant 1 samples. Rather, the exposed binder appears receded, indicating a uniform erosion of material. EDX of

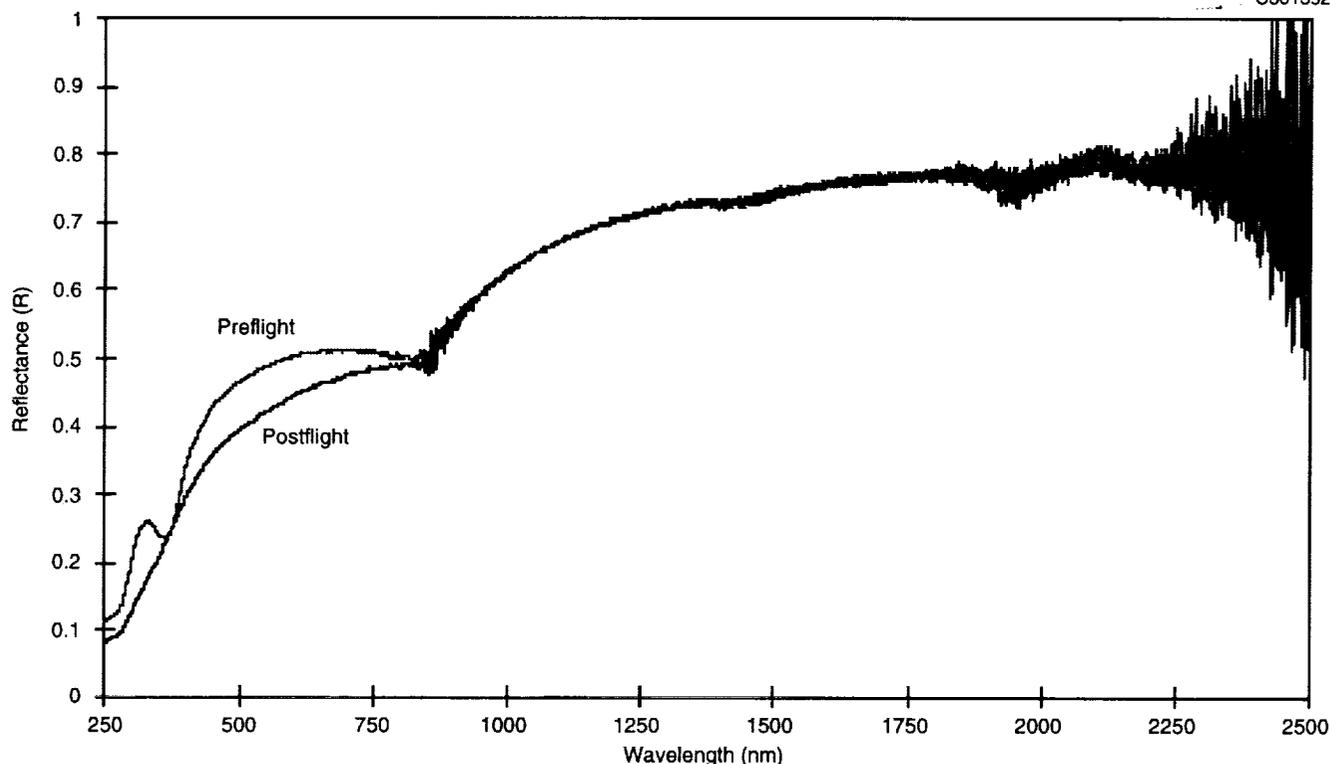
Figure 12. Pre- and postflight solar reflectance spectra for non-dyed sulfuric acid anodized 2219-T851 aluminum.

The post-flight optical property results for the anodic coatings are shown in Table 7. After 42 hours of exposure in the LEO environment, the non-dyed SAA on 7075-T73 showed very little change in absorptance. The increase in absorptance of 0.01 is within the error of the measurement device. The increase in absorptance for the 2219-T851 sample ($\Delta\alpha = 0.03$), which is slightly more significant, can be attributed to UV degradation and contamination. UV degradation of anodic coatings is generally logarithmic with most of the degradation occurring in the first 200 hours.³ When the degradation is attributed solely to UV degradation, and a logarithmic degradation is assumed, the 30-year predicted degradation is below 0.10. This is well within the 30-year absorptance degradation of 0.20 that was predicted for this coating.³ The effect appeared to be confined to the wavelength range below 850 nm. Lambda 9 reflectance spectrums for the pre-flight and post-flight measurements are shown in Figure 12. The confinement of absorptance effects to this narrow wavelength range may be attributed to the presence of silicone, which was detected in a 4-keV beam energy EDX study of the 2219-T851 flight sample. In addition, the affected wavelength range includes wavelengths at which the incident energy from the sun has the highest potential to induce rupture of chemical bonds.⁹ It is not clear from the data available why the 2219 substrate degraded more than the 7075 substrate.
